# Other Indicators: Oxbows

## **CALOOSAHATCHEE SCIENCE WORKSHOP FGCU - FORT MYERS**

November 20, 2013

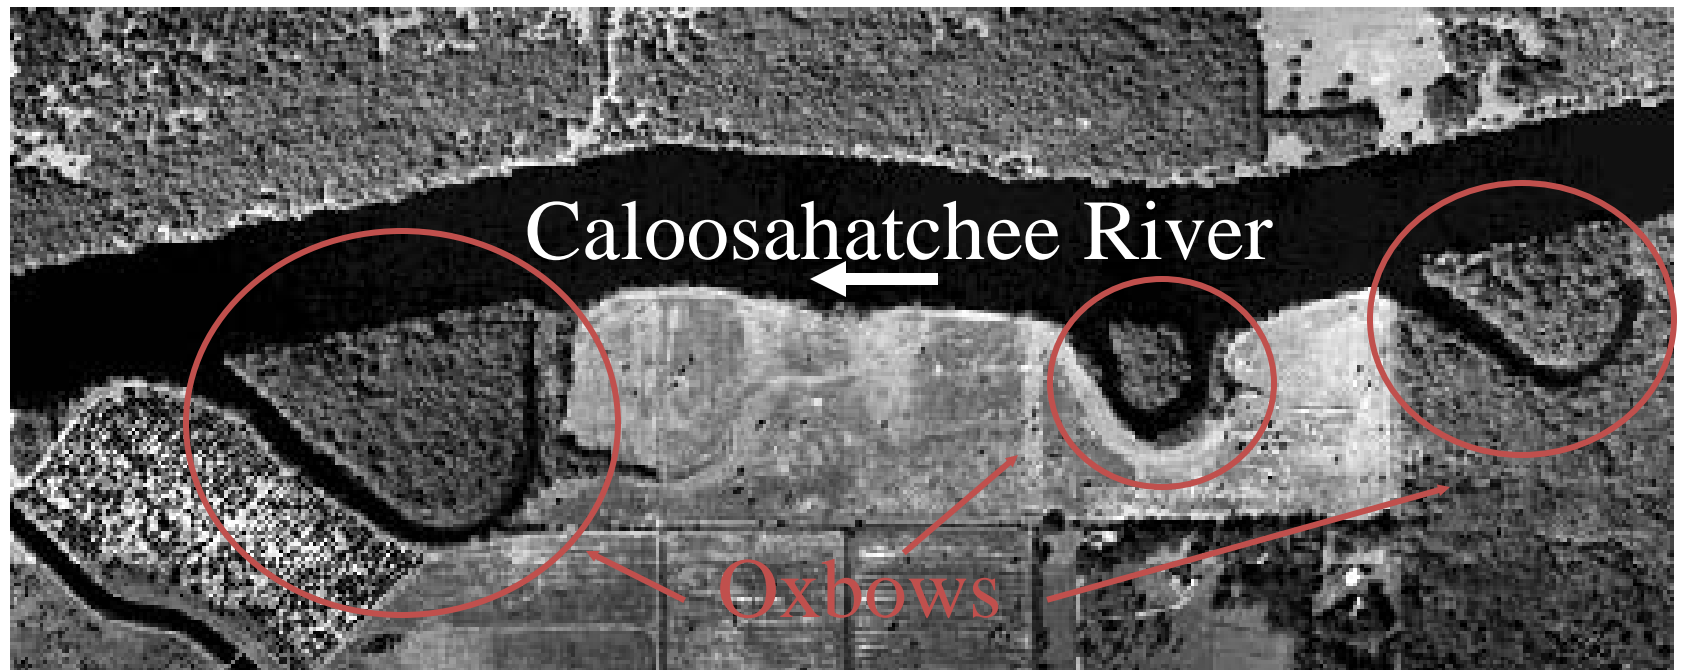
- **Oxbows:** U-shaped water bodies on each side of the river channel, which are the remnant bends of the original river
- Close monitoring of the oxbows provides critical information to the river conditions.

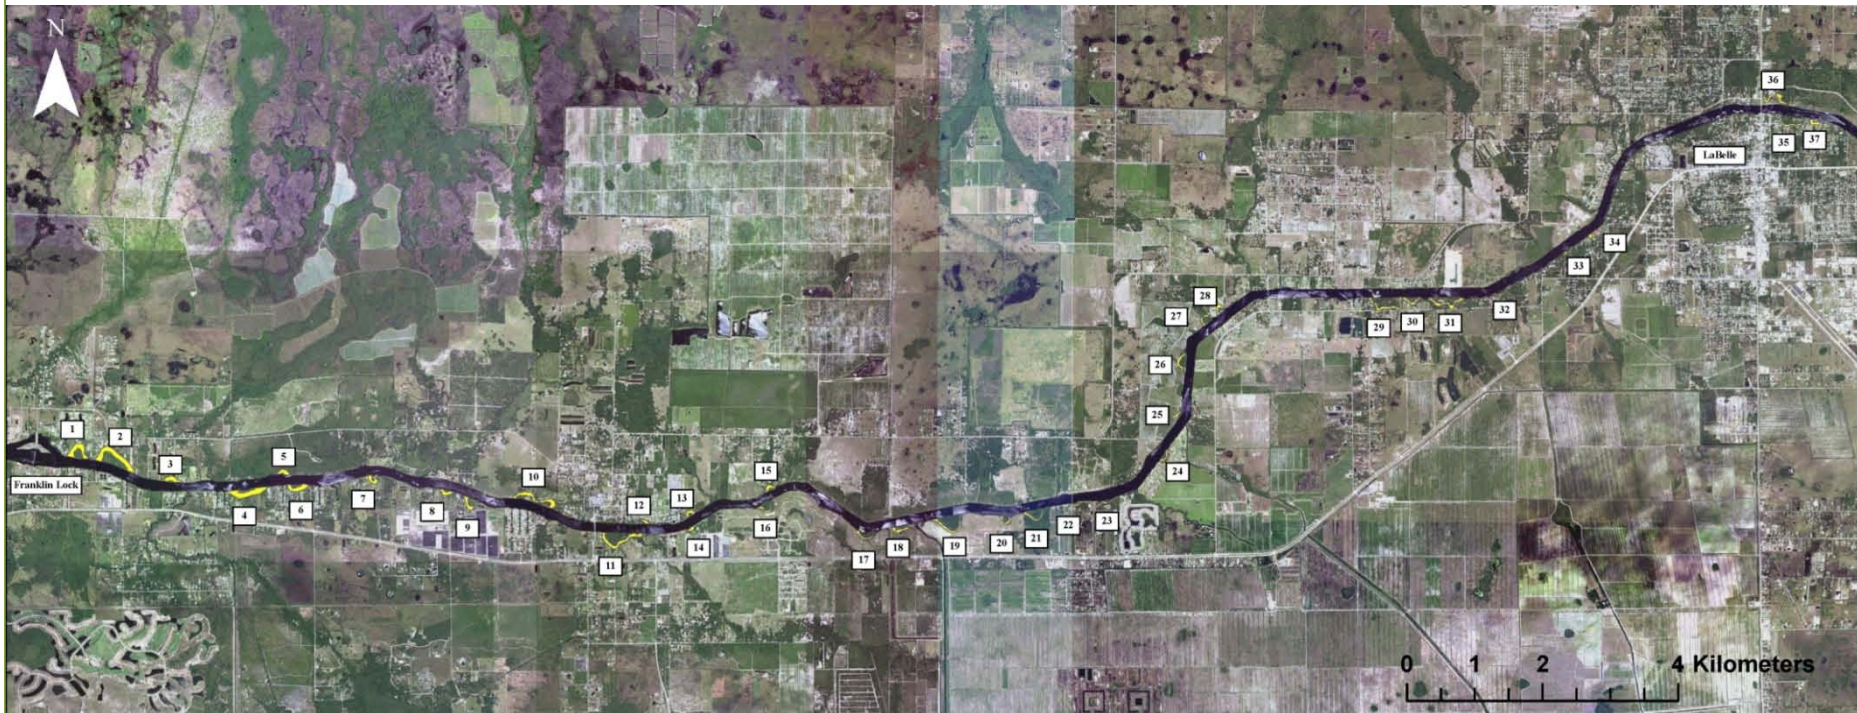
37 oxbows located between Franklin Lock and the City of LaBelle

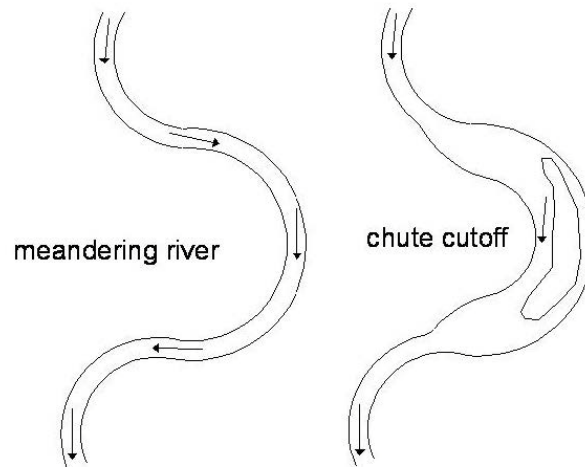
## Chute cutoff

4 phases:

- Bend preparation
- Short circuit
- Oxbow lake
- Infill

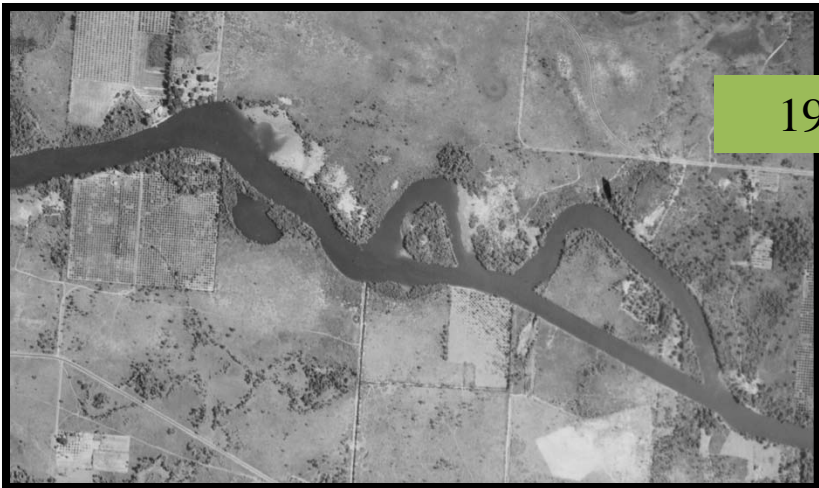
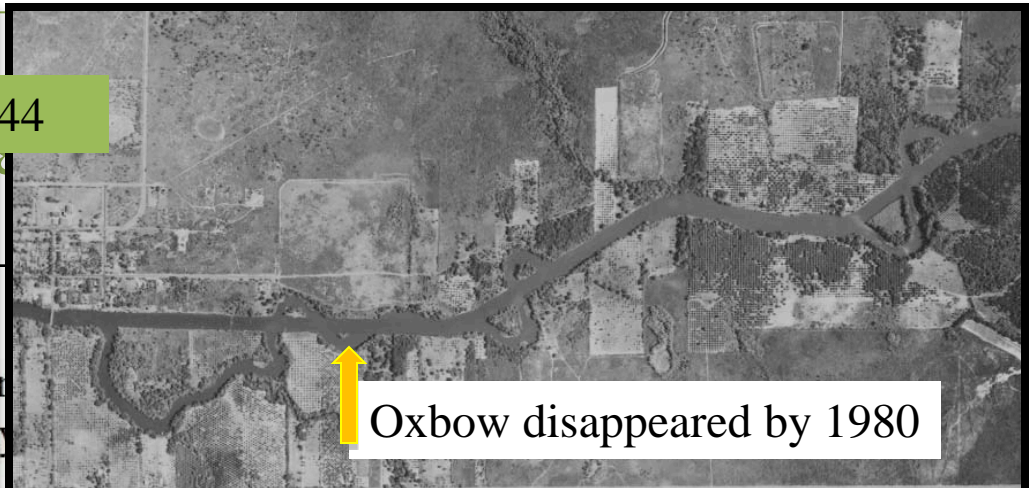
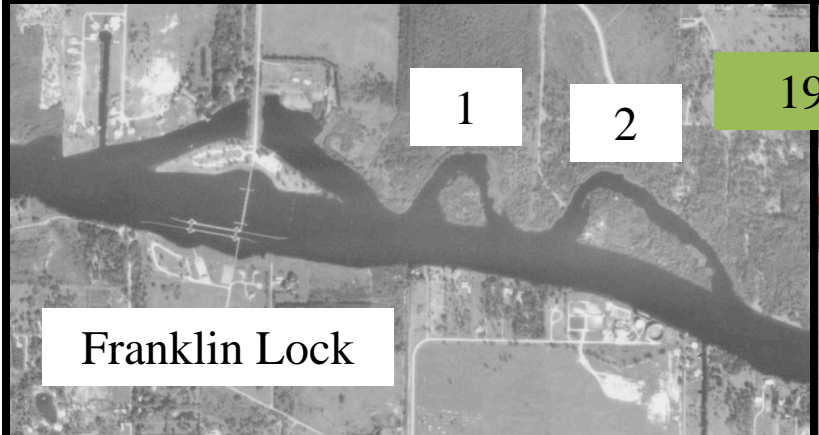
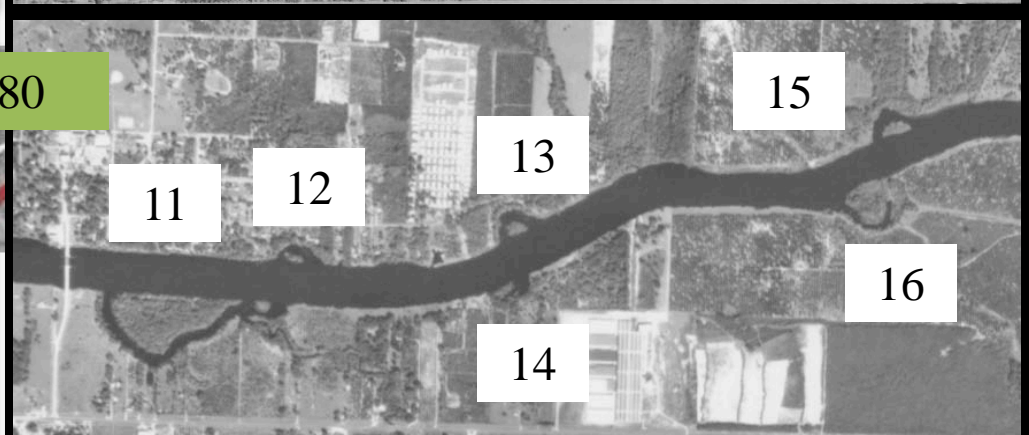
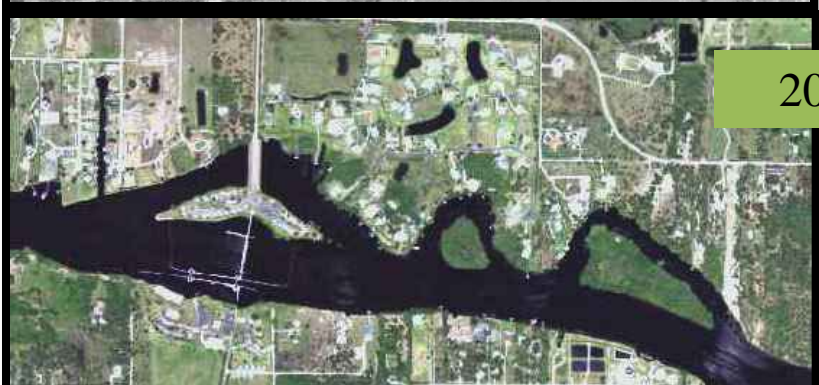
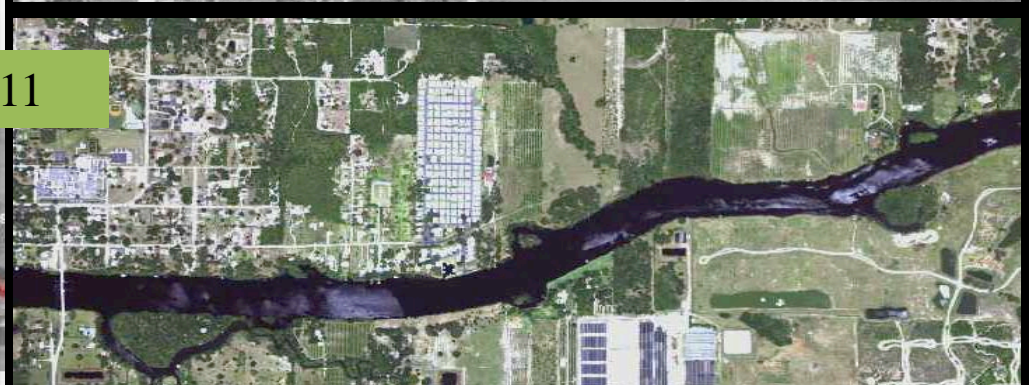
15 oxbows disappeared between 1944 and 1980 with the widening of the channel

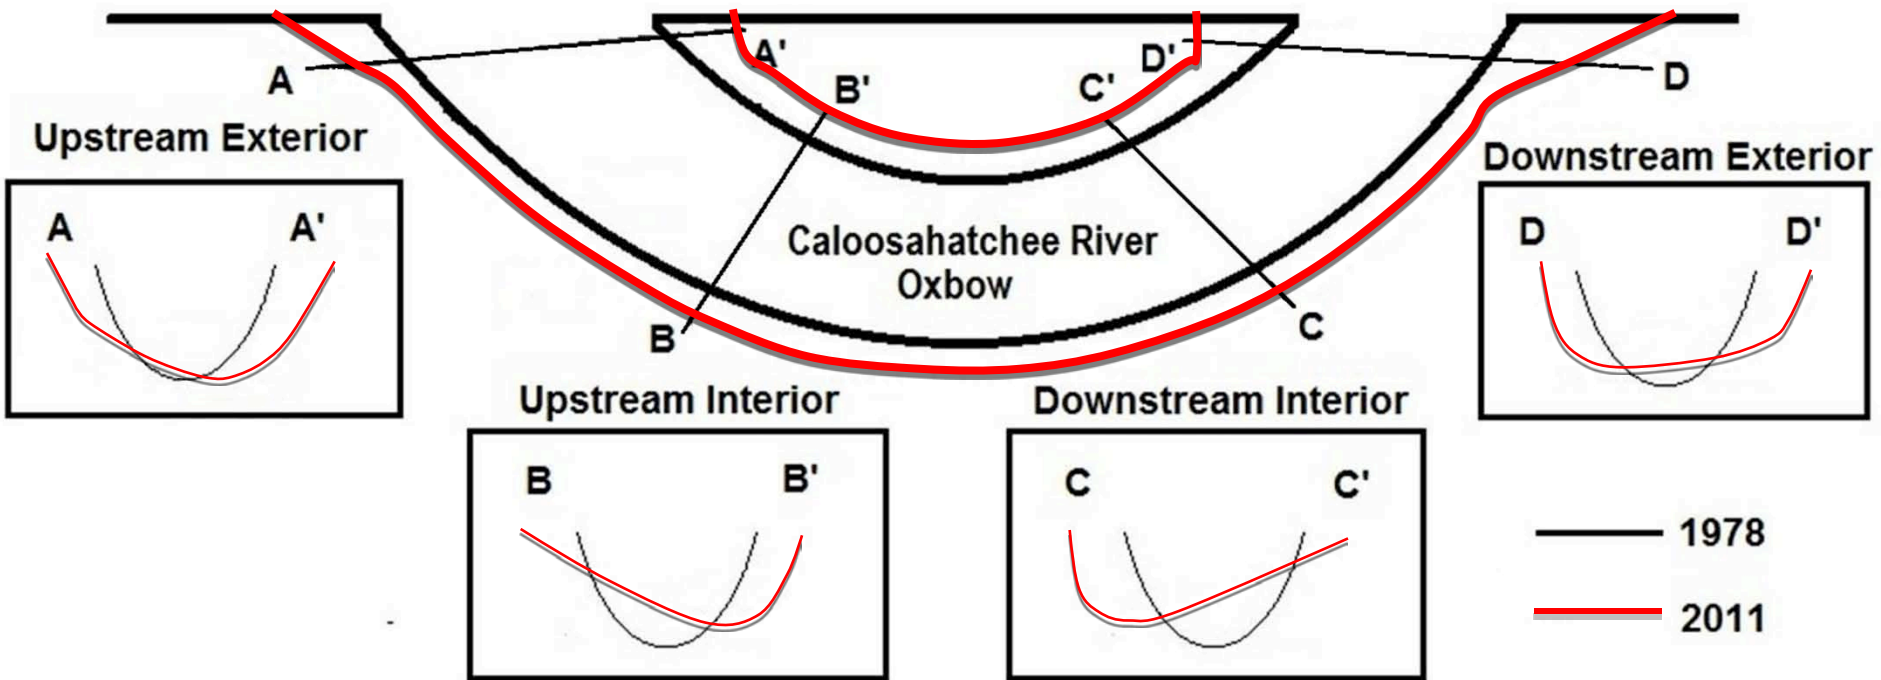
# Evolution Analysis

C-43 Canal

Flow →
